Monitoring Data Record

Project Title: B-3126 (Br. #90 over Gunpowder Creek on SR 1718)  
 COE Action ID: 2007-1591-214 DWQ Number: 070583  
 Stream Name: Tributary to Gunpowder Creek  
 City, County and other Location Information: Caldwell County, Bridge #90 over  
Gunpowder Creek on SR 1718 (Deal Mill Road) near Granite Falls.  
 Date Construction Completed: 3/11/09 Monitoring Year: ( 4 ) of 5  
 Ecoregion:  8 digit HUC unit 03050101  
 USGS Quad Name and Coordinates: Granite Falls N 35.84415, W 81.43603

Year 4 Summer – August 2012

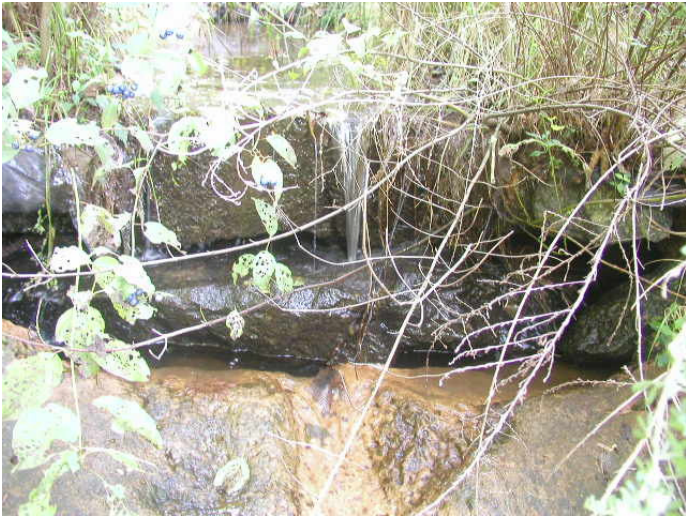
Water flowing over crossvane @ Sta. 2+40-NSD-

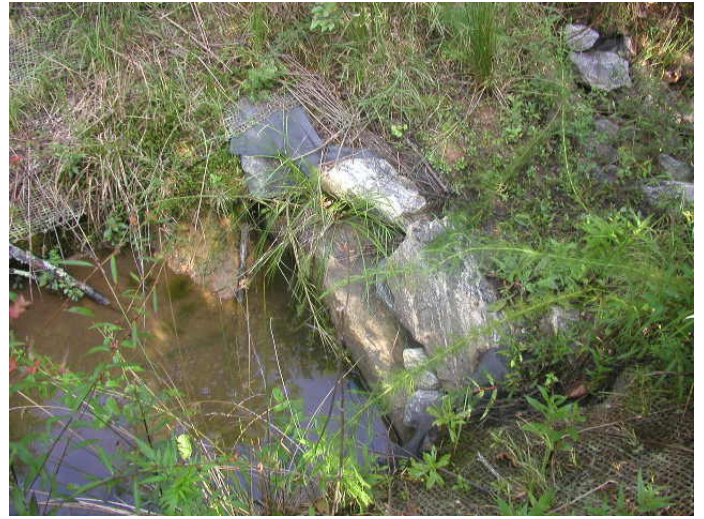
This is the Year 4 Summer evaluation for the Tributary to Gunpowder Creek. Water continues to pipe under the crossvanes at Sta. 2+50 -NSD- and 3+10 -NSD- but does not appear to be causing any instability issues at this time. On two separate occasions in December 2011 and in January 2012, NCDOT attempted to repair the crossvanes. NCDOT will continue to monitor the channel stability at this stream relocation.

Water piping under crossvane @ Sta. 2+50-NSD-

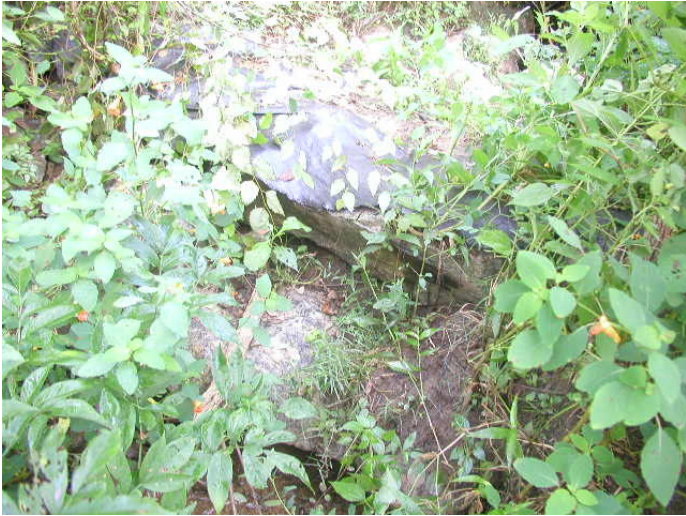
Water piping under crossvane @ Sta. 3+10-NSD-
